HISTORICAL SUMMARY OF COAL-MINE EXPLOSIONS IN THE UNITED STATES

KENILWORTH MINE

BY H. B. HUMPHREY

Information Circular 7900

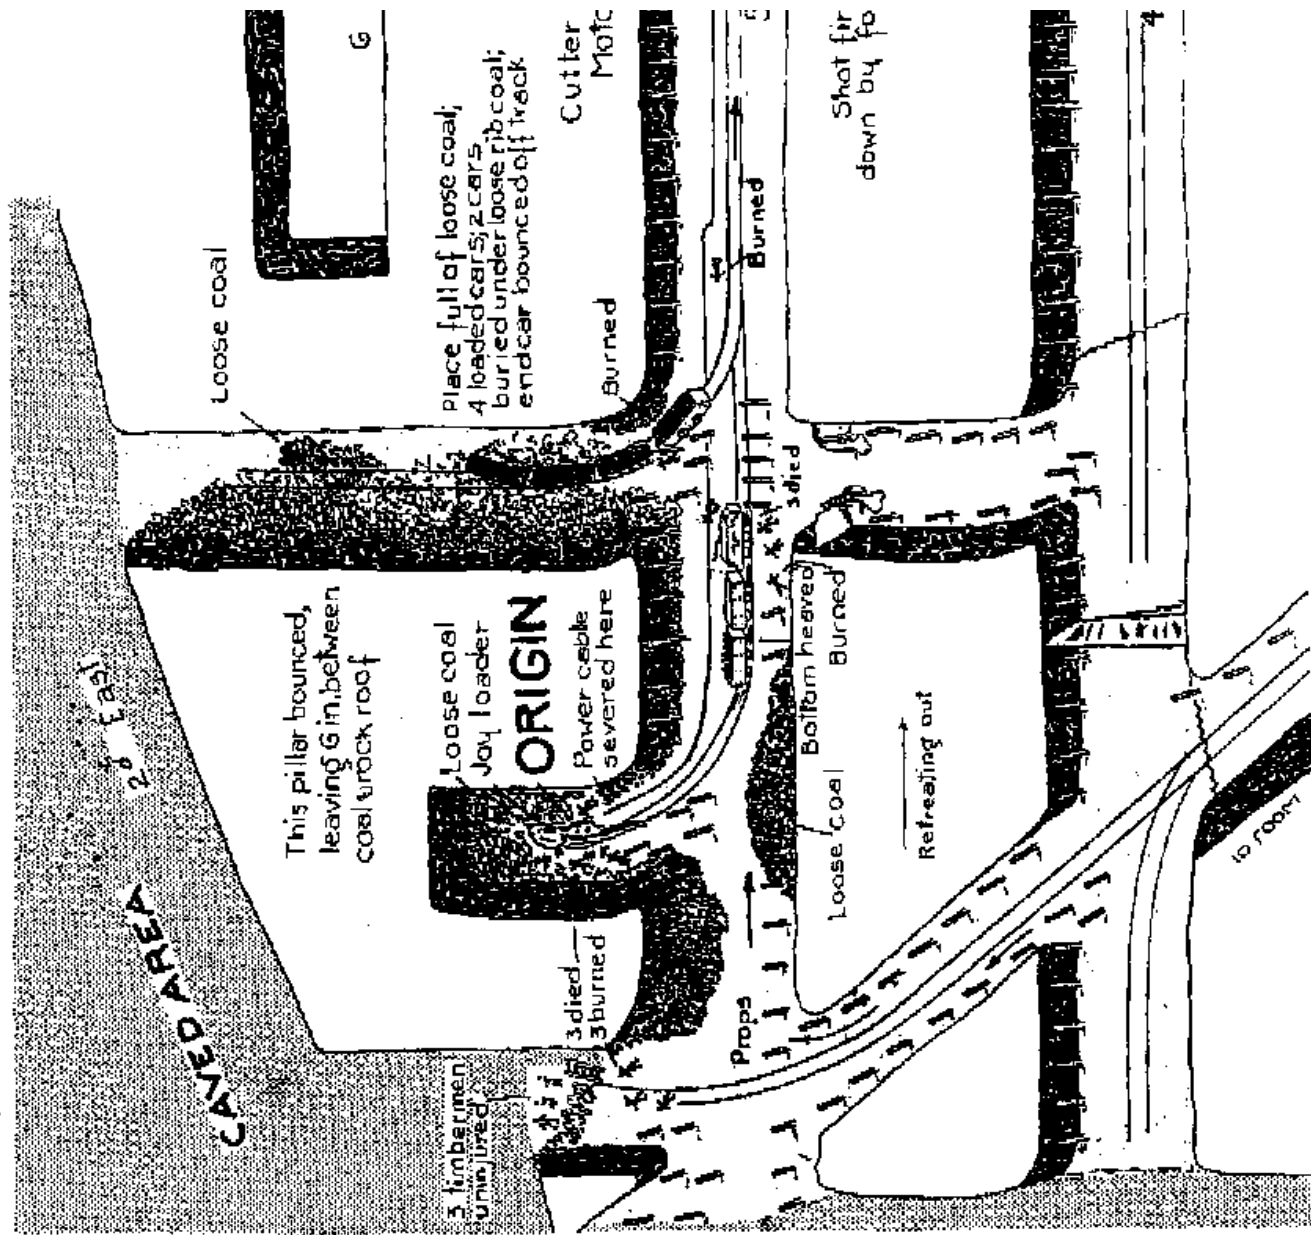
FIGURE 142.—Sketch of explosion area, Kenilworth mine, Kenilworth, Utah, Mar

*Kenilworth — Classic bump scenario,
splitting pillar at corner projection.*

At 1:15 p. m. 16 men were working in No. 5 pane on the 3d east entry off No. 2 slope, when a severe bounce occurred in the pillar that was being mined next to the caved area. Although all of the electrical equipment in the panel was idle, the flying coal pulled the trailing cable of a loading machine with such force that it was severed and short-circuited on the edge of the pipe conduit entering the machine. An arc was formed that ignited the coal dust and methane in the air as a result of the bounce. Flame filled most of the area and burned 12 of the men severely. A shot firer just outside the flame was knocked down but not injured, and three timbermen also beyond the flame were not affected. The shot firer cut off power from the section and telephoned to the dispatcher for assistance. The injured men were given first aid and removed to the hospital. All men were sent out from other sections. Later seven of the injured died.

The coal thrown from 1 side of the pillar filled a crosscut to a depth above the tops of the cars, 50 inches high. A section of the pillar 60 by 40 feet had been thrown out to a depth of 6 inches below the roof. Sur-

vivors stated that the flame lasted 10 seconds or longer. The well-rock-dusted condition of the mine confined the explosion to the immediate area (fig. 142). As a precaution a method was devised later for grounding cables and fog nozzles were used to allay dust. Water saturation of pillars was also adopted.
